The Building Science of Efficient Envelopes

Home Efficiency Forum Emily Kemper (CLEAResult) David Heslam (Earth Advantage)

Thermal Break Shear Wall

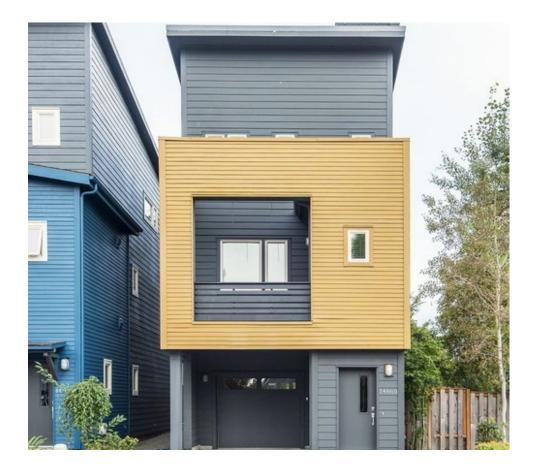
New Construction Example

- Net Zero development
- Used Thermal Break Shear (TBS) walls
- 1.25" EPS foam board between the lumber frame and plywood sheathing

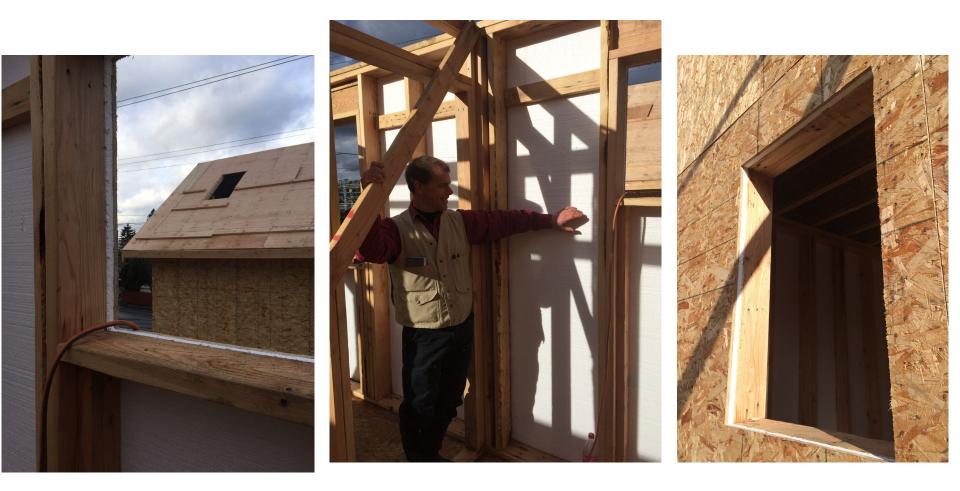
New Construction Example

- Greater total lateral load capacity & earthquake resilience
- Sheathing nailing: 3"
 o.c. edges, 12" o.c. in the field
- Cost-effective solution to thermal bridging

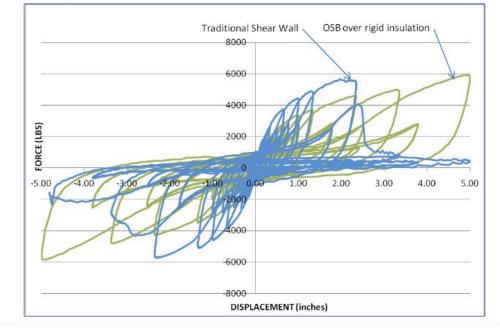
Figure 3. Comparison of Traditional Shear Wall with TBS Wall

- Revealed major changes to structural characteristics compared to conventional lightframe walls
- Much more flexible
- Higher lateral load capacity
- Greater resilience in the face of the racking motion typical of seismic events

- Use of foam as a thermal break = 25-40% improvement in energy performance
 - + created a continuous air barrier
- Enhanced nailing pattern = increased seismic resilience outperformed cyclic load testing
 - Conventional assemblies reach capacity at 1-3/4" of deflection, whereas TBS reached protocol max deflection of 5"

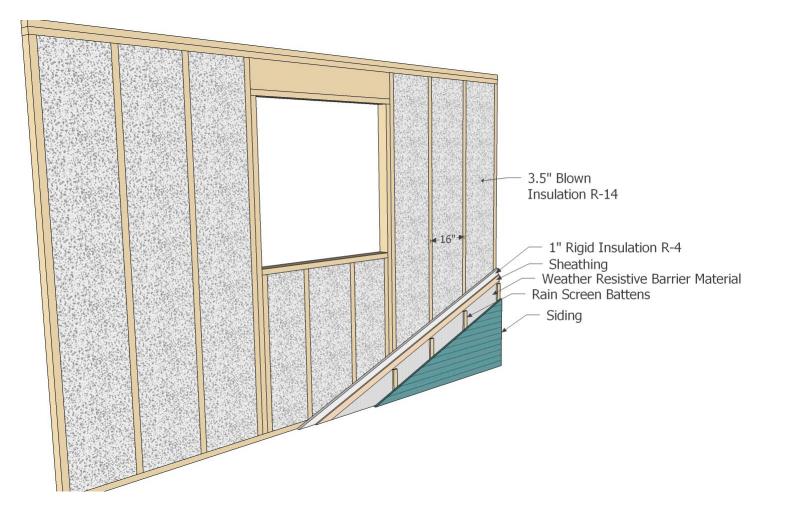
Thermal Break Shear Wall

"A continuous layer of rigid foam insulation between the structural sheathing and standard framing with an enhanced nailing pattern"

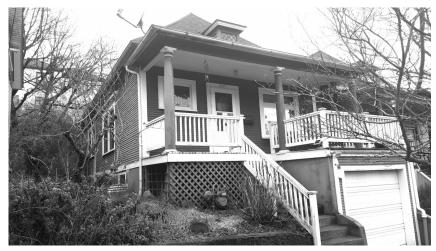
The Retrofit Project Site

- Identified a retrofit opportunity of a single-family wood-frame house in urban location.
- 1906 house within South Portland Historic District.
- Excellent prototype of siding replacement project (although complicated by location in historical district)
- Site altered from originally proposed location/type (small multifamily).

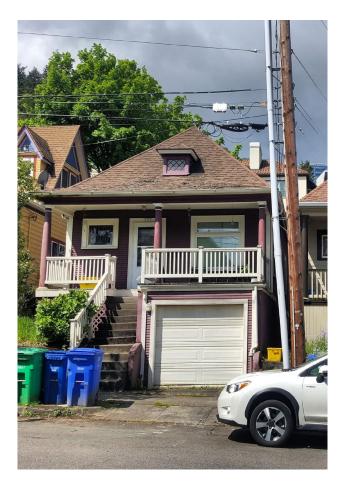
- 1. Remove existing siding.
- Insulate the exterior walls from the outside in adding layer of rigid foam insulation with plywood sheathing to create shear wall.
- 3. Nail sheathing with enhanced nailing pattern.
- 4. Adjust sills and flashing around the existing windows.
- 5. Install new siding and painting it.

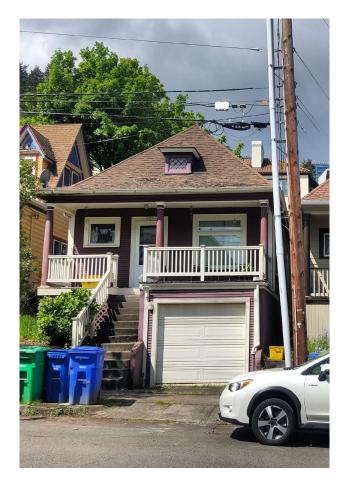
- 1" rigid Extruded Polystyrene Board Insulation (XPS) was specified.
- Owens Corning provided 1" x 48" x 96" panels of their FOAMULAR™ 150 product. Closed cell, moisture-resistant rigid foam board
- 7/8" Oriented Strand Board (OSB) was used for sheathing.
- TBS wall components are cut and assembled with standard products, tools, and fasteners.
- Sheathing at the exterior of the wall assembly provides a base layer that is compatible with tested fastener schedules for standard siding materials.
- The nailing pattern included field nailing with 16d nails at 12" on center and edge nailing with 16d nails at 3" on center.
- Additional 2x4 wall studs as needed.
- Window sill and door jamb extensions.

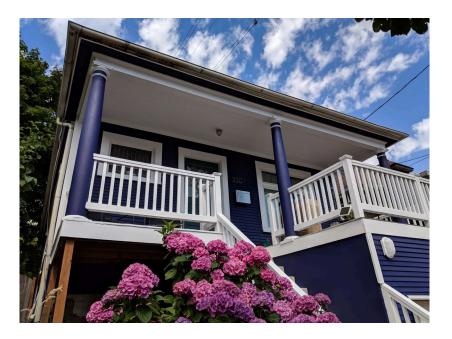
- This is not hard. Site assembled TBS wall is a relatively basic construction concept: to achieve performance, follow instructions, and it will go relatively quickly.
- We should try to apply this to larger multi-unit structures.
- Also: other people are doing this. TBS wall is being used in Habitat for Humanity builds in East Portland.

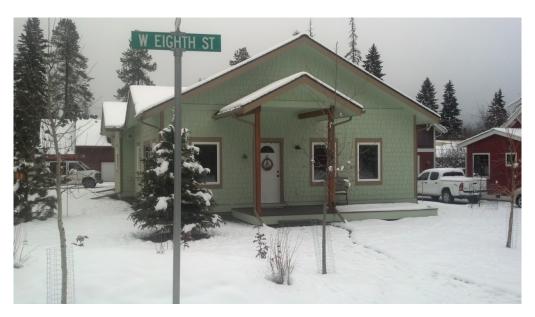
Double Wall Section

- Wall spec: 2- 2x4 framed walls with 3 ¹/₂" gap between, Blown cellulose insulation
- Conditioned crawlspace with ICF walls
- Challenges:
 - o Air barrier framing
 - Air sealing details
- Success:
 - 1.3 ACH₅₀
- ICF walls less susceptible to seismic or high wind loads

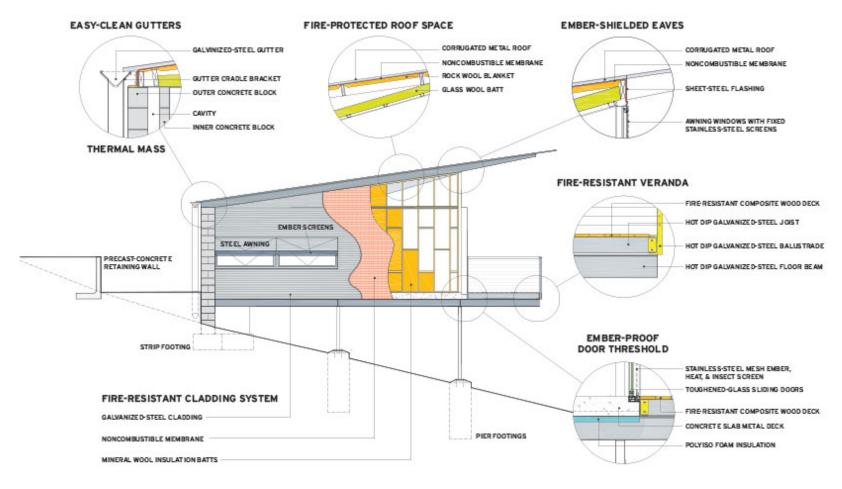
KARRI FIRE HOUSE'S FIRE-RESISTANT STRATEGIES

- Many existing efficient wall types can be made more resistant to wildfires
- The key is using non-combustible materials on exterior surfaces of the house, particularly with wall sheathing and exterior cladding
 - For siding, specify non-combustible, ignition-resistant material, such as fiber-cement siding, brick, or stucco
 - For roofing, use Class A, fire-rated materials such as standing seam, tile, slate, or cementitious composite roofing
 - Design eave soffit spaces and underside of roof rafters to resist building ignition from airborne embers
